Putting the “Kinks” Back in Little Butte Creek

By Brian R. Barr

Updated November 30, 2011

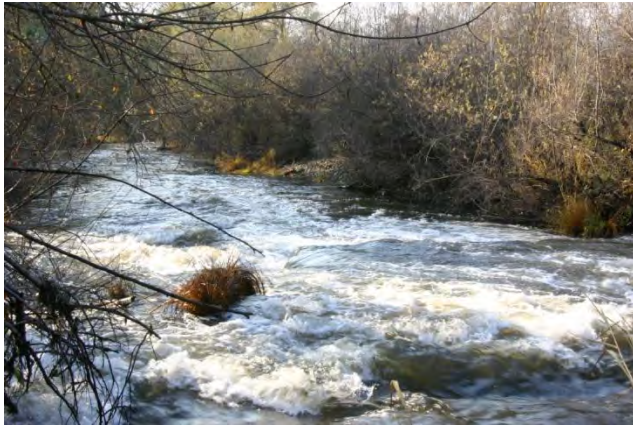
The former Little Butte Creek channel did not access its floodplain during typical winter floods.
